Historical Evidence: maps, photographs and aerial photographs

Evidence – The recording of Barton-le-Clay Footpath No. 9 on the Definitive Map

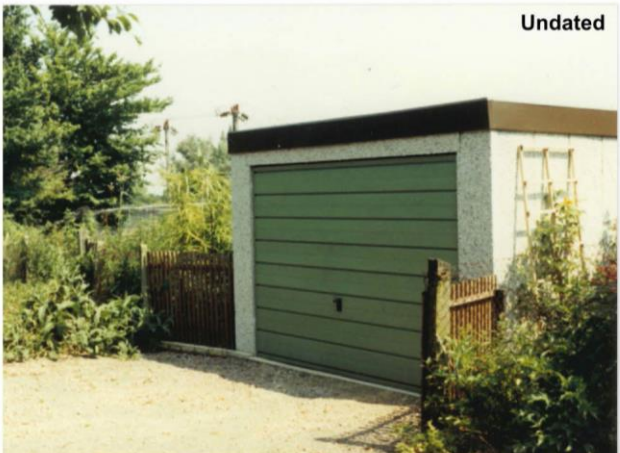
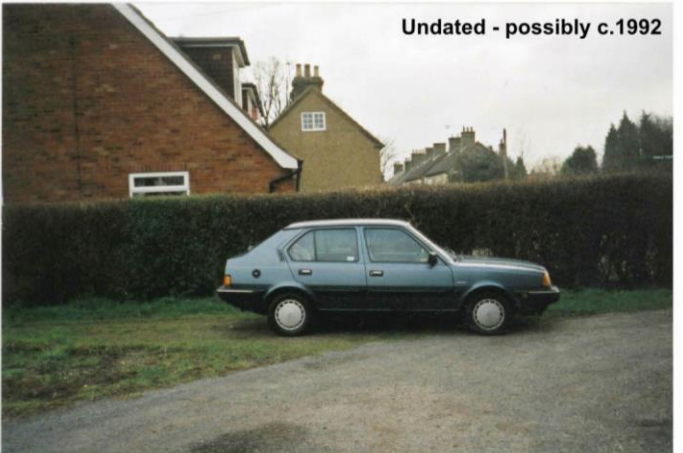
- C.12. Mr. and Mrs. Vincent have provided the Council with coloured photographs of the track. These record how this section of Footpath No. 9 looked in the 1990s, see overleaf. Two photographs taken in May/June 1990 provide a view taken from Mr. and Mrs. Vincent's garden looking towards the footpath at point A and to the meadow beyond (now the last phase of the Grange farm Buildings housing estate). The second photograph taken from near point B shows Mr. and Mrs. Vincent's garage and car at point C. The new stone surface and width of the track can clearly be seen, along with the original fence.

- C.13. A June 1992 photograph shows Mr. and Mrs. Vincent's new car parked along the footpath at point C. Although the sides of the footpath are overgrown, there is still over a clear car's width available (calculated at 2.3 metres based on the car's width). Also noted from this photo is the predominantly stone surface of the footpath.

- C.14. The photograph taken in February 1995 from near point D shows the footpath covered in snow. All vegetation has died back and the whole track is available for use. The available width is calculated as 3.5 metres based on Volvo 340 car tyre tracks seen in the photo, indicating it was used by vehicles at this time. In the distance the remnants of some fencing and what might have been the post for the stile can be seen where the footpath enters the field beyond. The gap in the fence is placed centrally in the track.

- C.15. Two photographs have been submitted showing how the footpath looked like post September 1996. The photos show Mr. and Mrs. Vincent's compact car at point C. These indicate that a significant proportion of the width of the track available for use, although the western side is encroached upon by vegetation, including trees. In the distance the Grange Farm development is visible and a telegraph pole has been erected on the footpath. The shadowed areas of the photographs have been enhanced to show up details of the chain-link fencing and surface material and a grassed strip up the middle of the track. Two other photographs are not dated; however the one showing Mr. Rogers' hedge and the original footpath sign could be c.1992 (based upon the car featured).

- C.16. The photographs suggest that during the winter months the die-back of annual vegetation allowed the majority of the track to be used, although overgrowth of more woody vegetation and brambles did impinge upon the western side of the track. In the summer months, vegetation growing along the margins of the track reduced its usable width slightly to the central 2-3 metres of the track. A later 2009 Google Streetview[®] image (see Appendix D), taken prior to the period when the path was temporarily closed shows that at this time there was upgrowth of vegetation on the track and that the trees of No. 44 had grown over the footpath significantly.

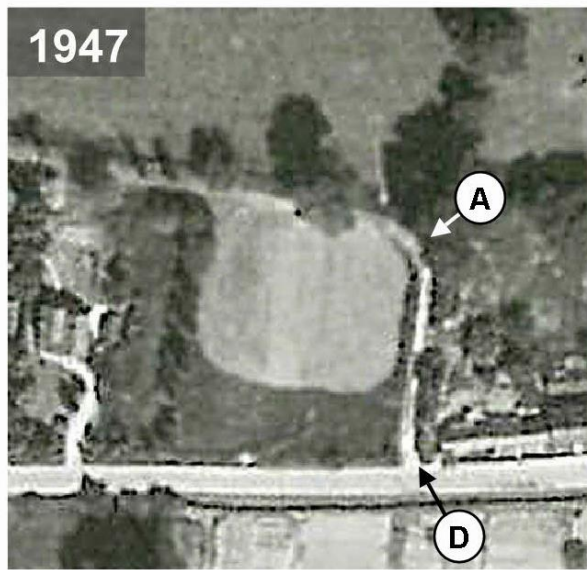
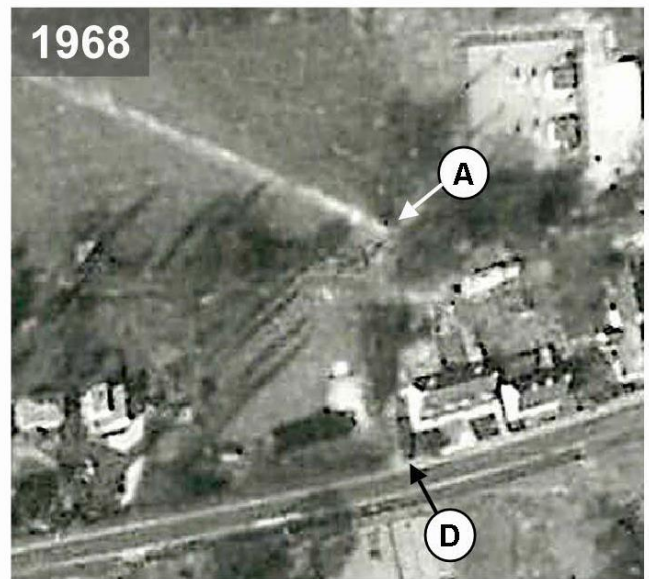
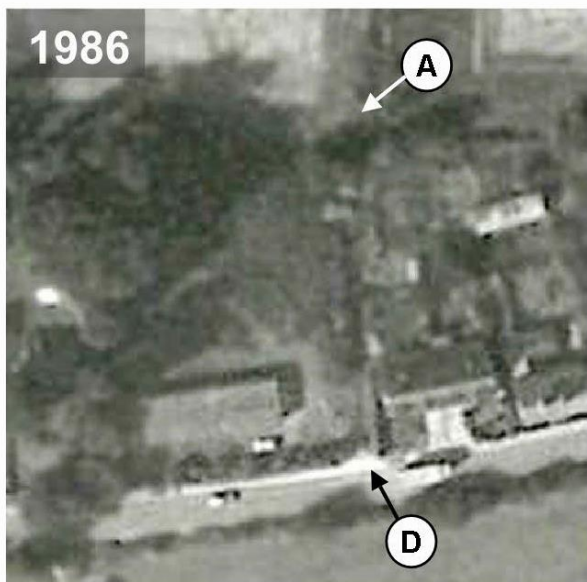
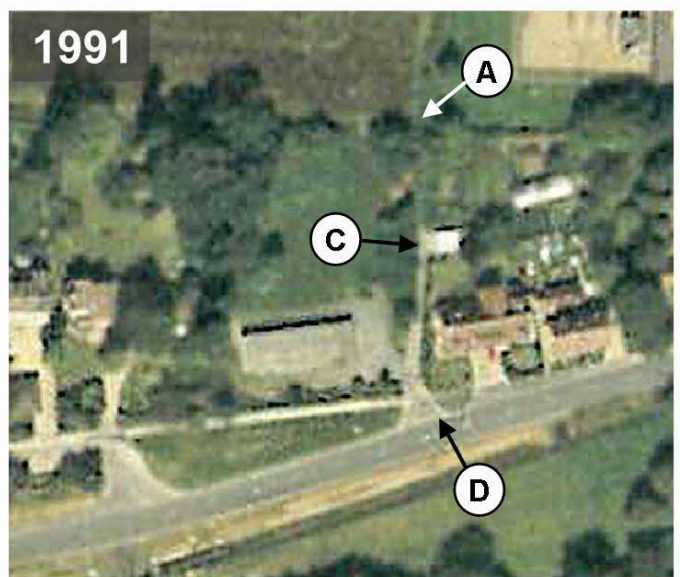
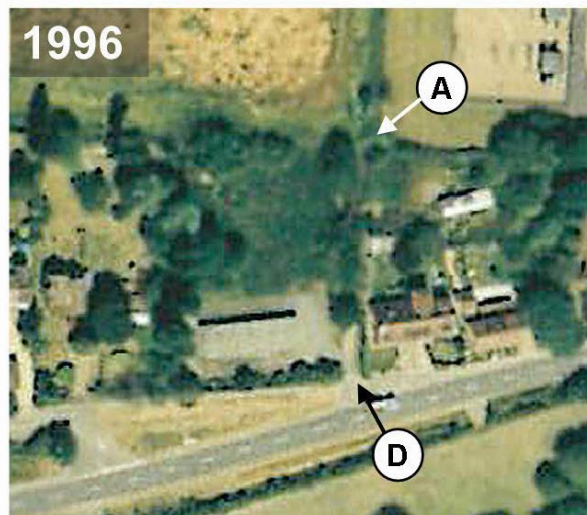
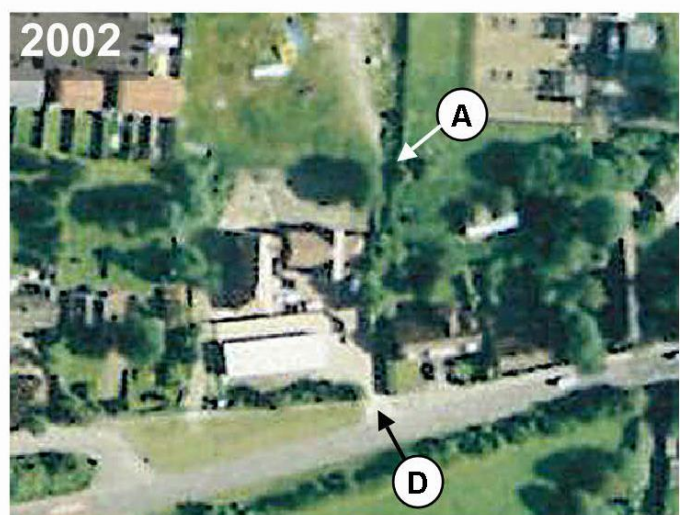
Aerial photographs of the southern section of Barton-le-Clay Footpath No. 9

- C.18. The 1947 aerial photograph shows a well established vehicular route along the eastern and northern boundaries of a large plot, now occupied by Nos. 44 and 46 Sharpenhoe Road and the old church building (now redeveloped as a private residence). The section of track along Footpath No. 9 is delineated by mature hedging to the east and possibly a shorter hedge with shrubs to the western side. The useable width of the track appears to be approximately 1.9 - 2.5 metres wide.

- C.19. By 1968 the track is less distinguishable and the shrubs/trees to the western side appear to have grown quite tall. Where visible, the track is approximately 3.0 metres wide. There is no sign of a track along the northern boundary of the plot and the old (now redeveloped) church has been built next to the road.

- C.20. Significant vegetation growth has occurred by 1986 with the fruit trees being obvious. The track is only clearly visible at its southern end with a width of approximately 2.4 - 3.3 metres and the hedge adjoining No. 42 is well established at this time but appears cut well back from the track compared to its position in later aerial photographs.

- C.21. A clearer overhead aerial photograph in 1991 shows the track still exists with a visible width of approximately 2.0 - 2.8 metres. This runs abutting the eastern boundary which appears predominantly hedged with some mature trees to the northern end.

- C.22. The aerial photographs taken in 1996 and 2002 are obscured along the central section by overhanging vegetation. Glimpses of the track appear to show it to be at least as wide as a car where visible.

- C.24. The aerial photographs are difficult to interpret due to their lack of resolution, differing angles and the amount of vegetation obscuring or growing within the path. Despite this, the aerial photography between 1947 and 1991 clearly shows a track passing at least as far north as Mr. and Mrs. Vincent's garage. The 1947 aerial photograph clearly shows the track continuing around the northern edge of the plot. The width of the track during this period, where visible, appears to have been generally between 2.0 and 3.0 metres wide, depending on year and point measured. It is not possible to tell from the aerial photographs whether the track is narrow because of surface vegetation, hedge growth, or overhead tree growth.
